PROPERTY

**18 Foreshore Drive, Marlow Bay WA 6199**

**Inspection date:** 16 July 2026

EXECUTIVE SUMMARY

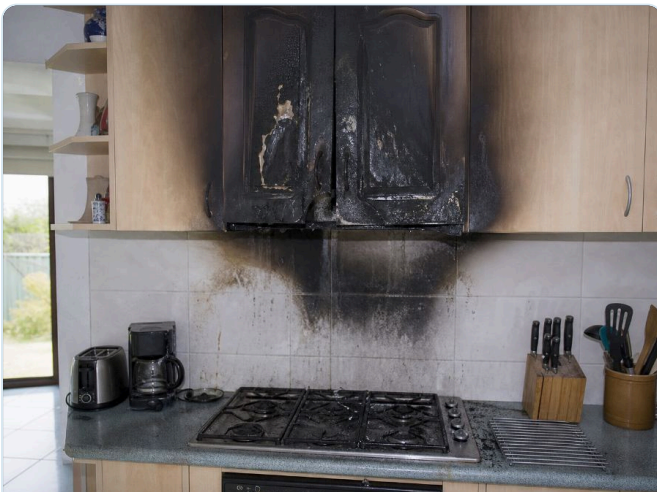
- **Cabinetry — severe heat damage**

Upper cabinets above cooktop charred; doors warped. Not salvageable. Recommend full replacement.

Photo 1 — Cooktop / cabinet heat damage

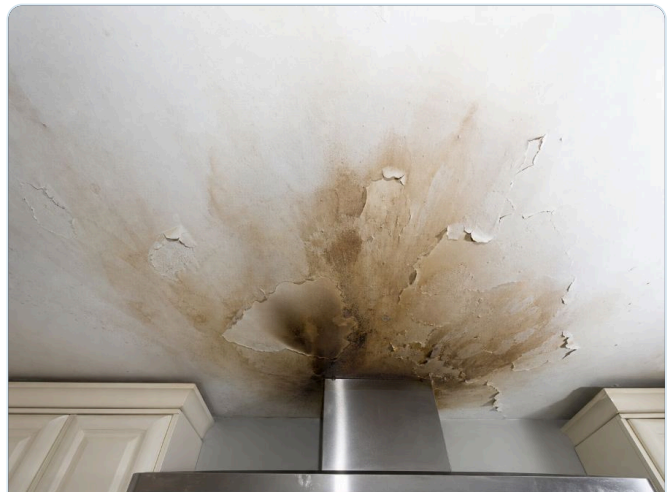
- **Ceiling — smoke staining & heat blistering**

Plasterboard directly above cooktop heat-affected. Re-sheet kitchen ceiling footprint.

Photo 2 — Ceiling blistering above range

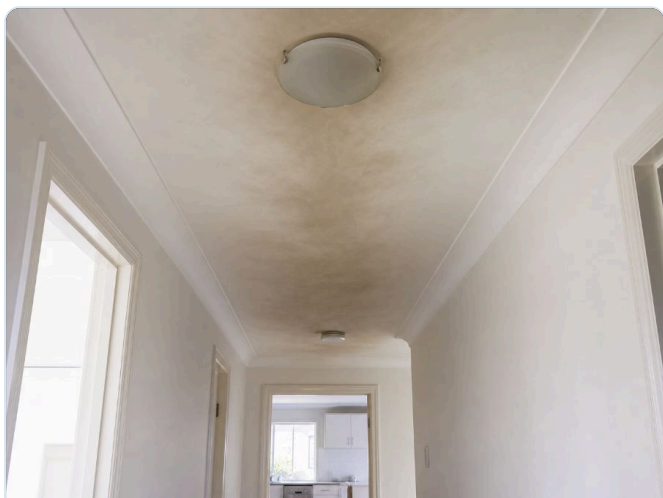
- **Ceiling — light smoke tracking**

Visible staining on corridor ceiling for ~2.4m from kitchen doorway. Local plaster repair and seal/paint.

Photo 3 — Hallway smoke tracking
